Inspection Report

Property Address:
2622 Miller Road
Hillsborough NC 27278

Jamey Tippens, LLC

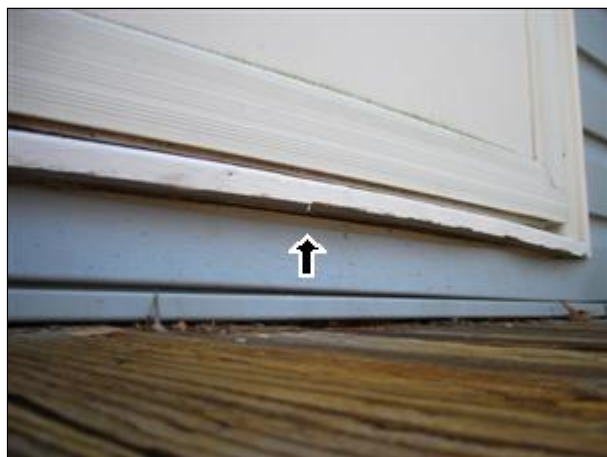
2.1 Picture 1

The threshold of the back entry door is bowed upward, which leaves a small gap below the threshold. See picture 1. Moisture or moist air could enter the framing through this gap. I recommend evaluation and repair by a licensed general contractor.

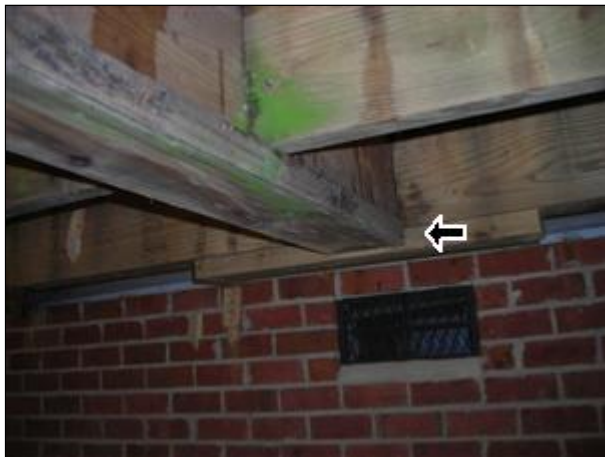
2.4 Picture 1

The deck on the back of the house may not be properly flashed. There is no evidence of flashing below the edge of the deck band against the house. Deck flashing keeps moisture from becoming trapped between the deck and house framing, and greatly reduces the danger of moisture damage to the framing. Once a deck is installed without flashing it can be very difficult to retrofit the flashing properly.

For the above items, I recommend evaluation and repair by a licensed general contractor.

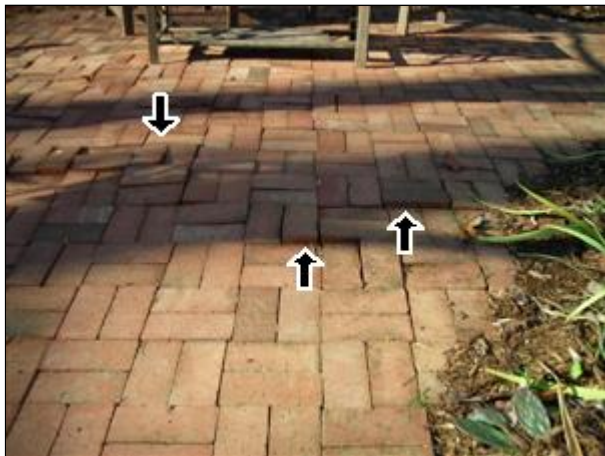
2.5 Picture 1

Some of the bricks in the back walkway have heaved up and could pose a tripping hazard. See picture. I recommend repair by a competent landscaping contractor.

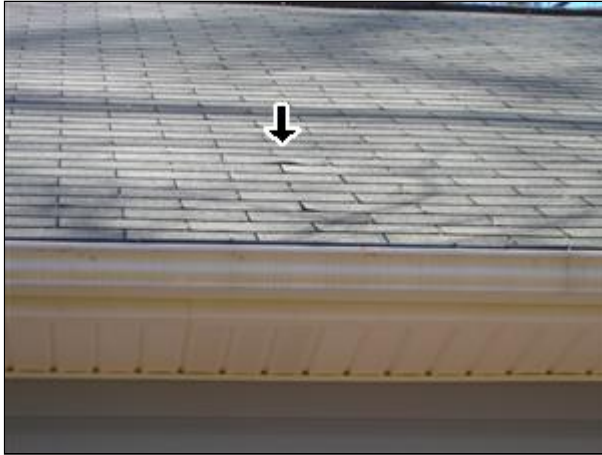
3.0 Picture 1

In a few places, shingles are slightly elevated due to nail pops, where the roofing nails have worked loose and raised the shingle above. See picture 1 for typical example. These places will eventually fail and create leaks as the nail works through the shingle. I recommend the popped nails be removed and the shingles repaired by a qualified roofing contractor.

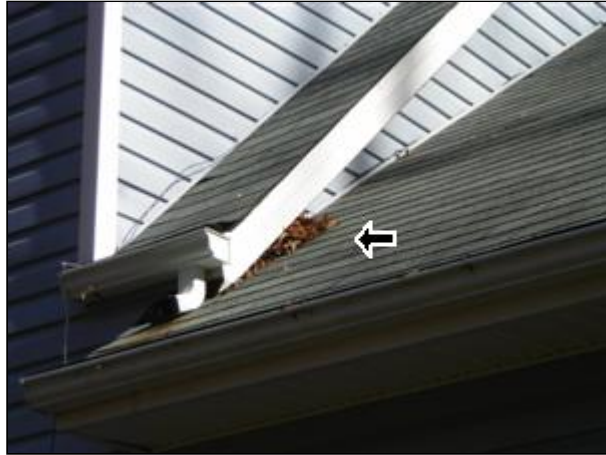
3.0 Picture 2

Leaves are trapped in an angle of the roof on the back side. See picture 2. This could cause a leak if water stands in that area. I recommend removal of the leaves by a competent handy person.

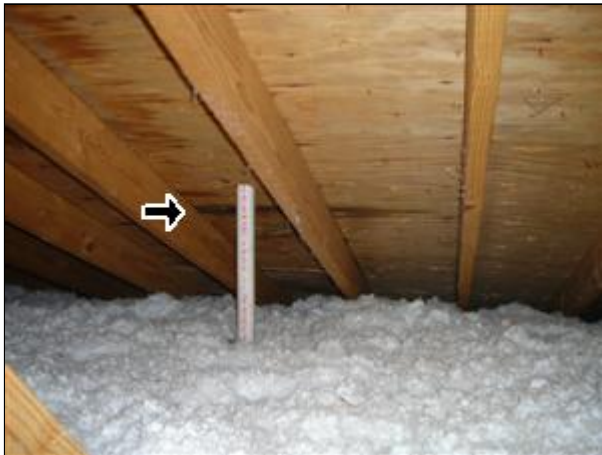
3.2 Picture 1

It is evident from staining on the ceiling of an upstairs bathroom that there is a leak from one of the plumbing vents in the roof. The picture below also shows a stain on the roof decking above this area. I recommend evaluation and repair by a certified roofing contractor.

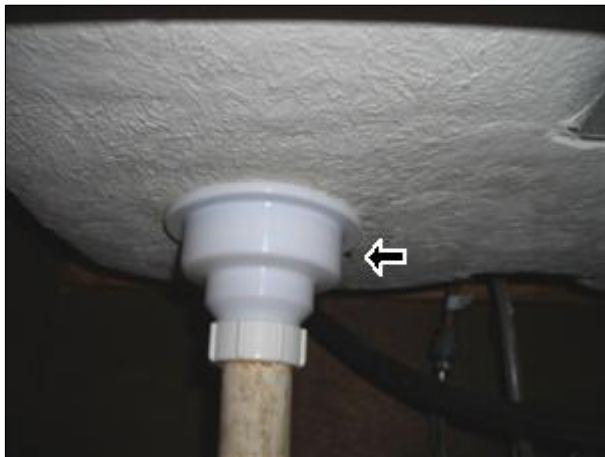
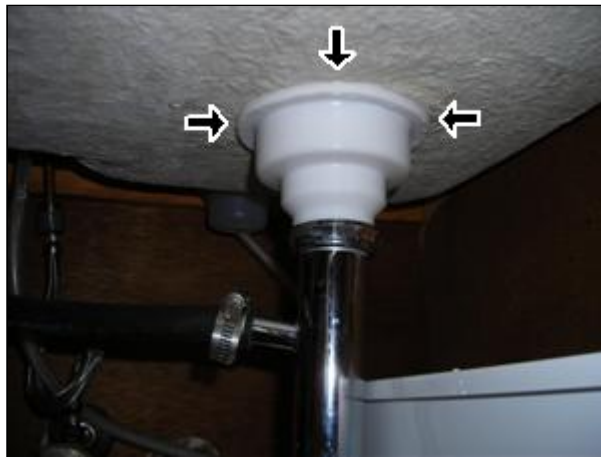
4.0 Picture 1

Both of the drains for the kitchen sink have minor leaks. See pictures 1 and 2.

For the above items, I recommend evaluation and repair by a licensed plumbing contractor.

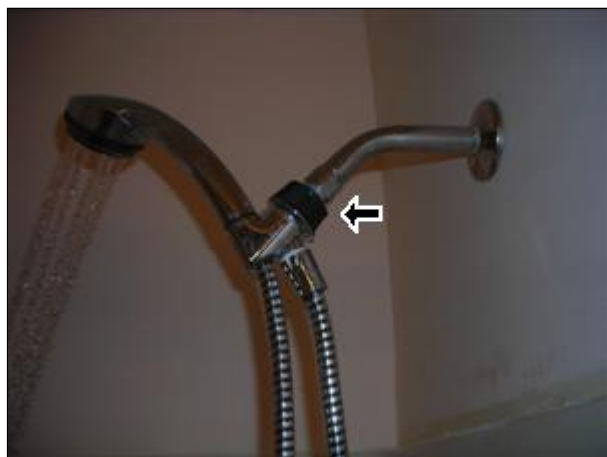
4.1 Picture 1

There is a small leak from the shower head in the upstairs back bath. See picture.

This could be repaired by a licensed plumbing contractor.

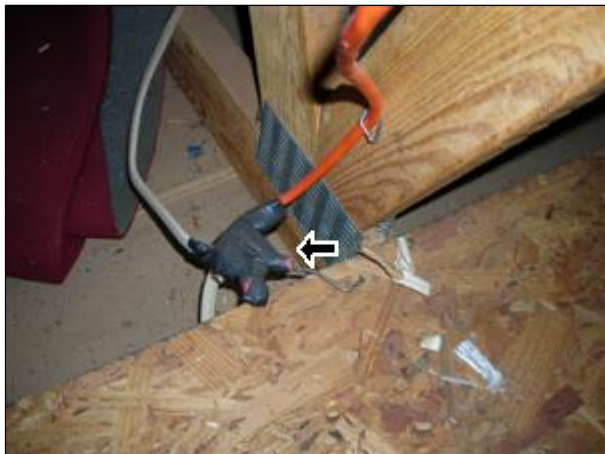
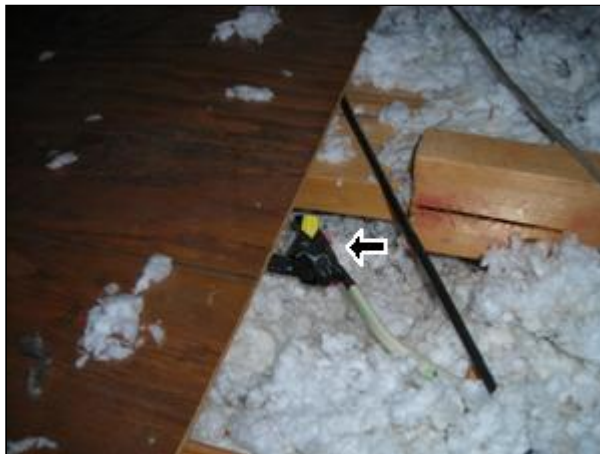
5.2 Picture 1

There are improper splices in both sections of the attic. See pictures. These connections were made to attach the power cables for the attic ventilation fans. Electrical splices should be made in junction boxes so that the wires are protected from damage, and so that workers are protected from electric shock. This could be repaired by a licensed electrical contractor.

The panel has an improper and potentially dangerous generator connection. Breakers connected to auxiliary generators should be set up so that the generator breaker and the main breaker cannot be both turned on at the same time. This panel does not have that feature. Should the main breaker and the generator breaker accidentally be left on at the same time, electricity from the generator could injure workers who may be repairing the electric service far from the house.

I recommend that the electrical system be evaluated and repaired as necessary by a licensed electrical contractor.

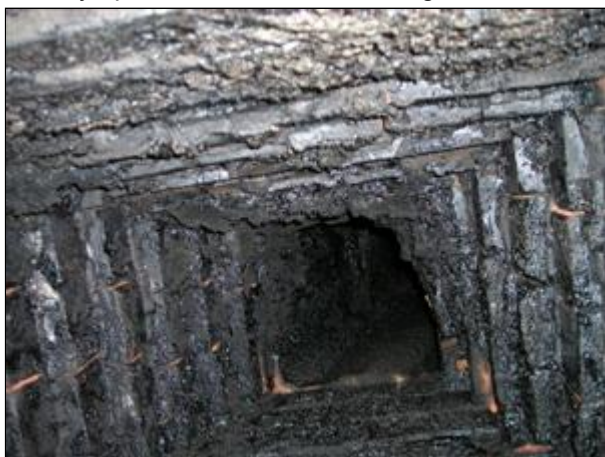
6.3 Picture 1

The fireplace chimney is very dirty. See picture 1. The chimney damper is missing its handle, so the damper will not stay open. I recommend cleaning, evaluation and repair as necessary by a certified chimney cleaner.

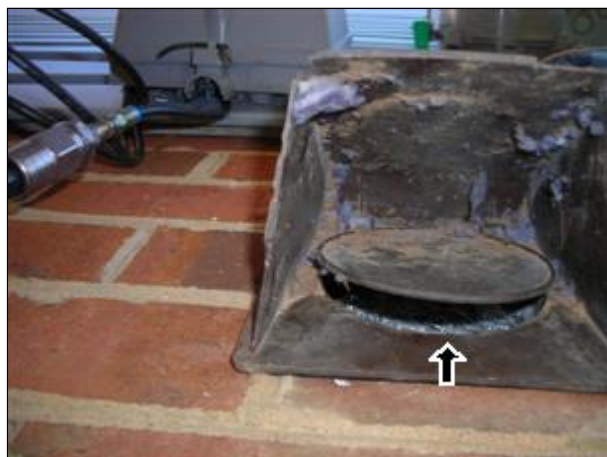
9.2 Picture 1

The dryer vent cap is partially clogged with lint and is stuck in the open position. See picture. This could allow back drafts and pests to enter the ductwork. I recommend that the duct and dampers be cleaned so that they work properly. A competent handy person could make this repair.

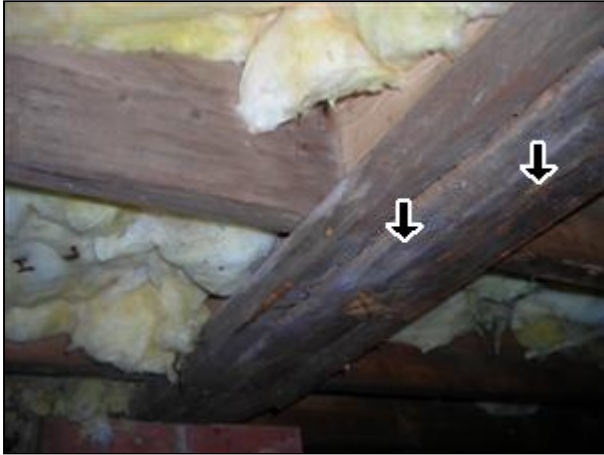
1.0 Picture 1

There are indications of long term condensation moisture on many floor joists and on the underside of the fiberglass floor insulation. See picture. The repairs to the floor mentioned in section 1.2 and the placement of an extensive vapor barrier may have corrected this problem. The soil is very wet under the vapor barrier on the back side of the house, but there is no indication of moisture entering through the crawlspace foundation walls.

I recommend monitoring of the crawlspace during the summer when the outdoor humidity is high by a person familiar with crawlspace moisture and its effects.

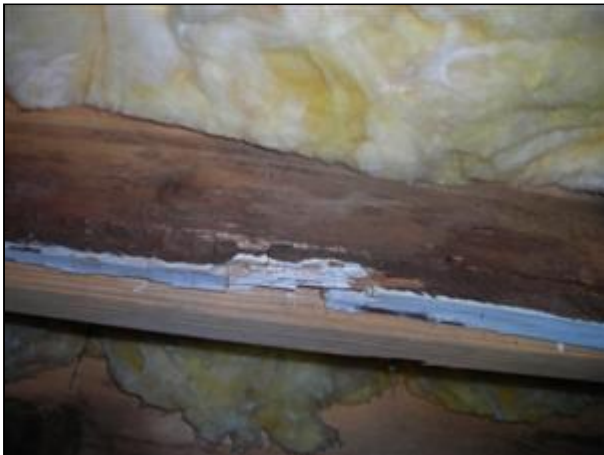
1.3 Picture 1

There has been damage to the floor framing under the living room, but this damage has been repaired adequately. See picture.

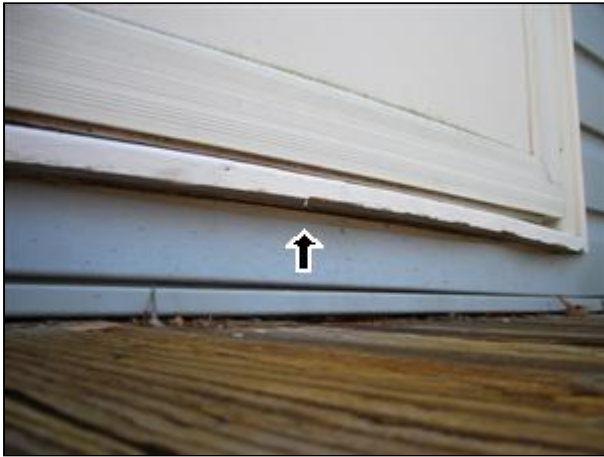
2.1 Picture 1

The threshold of the back entry door is bowed upward, which leaves a small gap below the threshold. See picture 1. Moisture or moist air could enter the framing through this gap. I recommend evaluation and repair by a licensed general contractor.

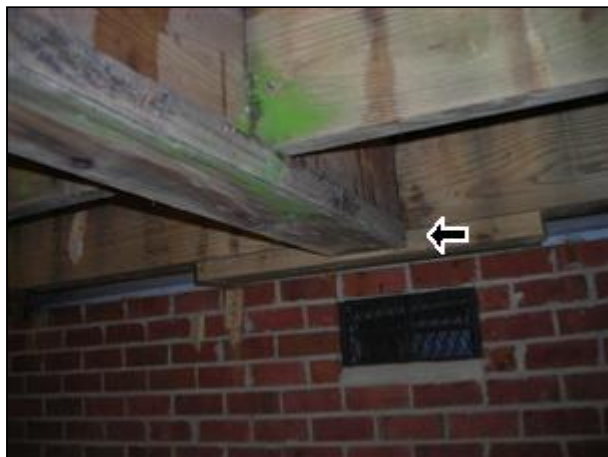
2.4 Picture 1

The deck on the back of the house may not be properly flashed. There is no evidence of flashing below the edge of the deck band against the house. Deck flashing keeps moisture from becoming trapped between the deck and house framing, and greatly reduces the danger of moisture damage to the framing. Once a deck is installed without flashing it can be very difficult to retrofit the flashing properly.

For the above items, I recommend evaluation and repair by a licensed general contractor.

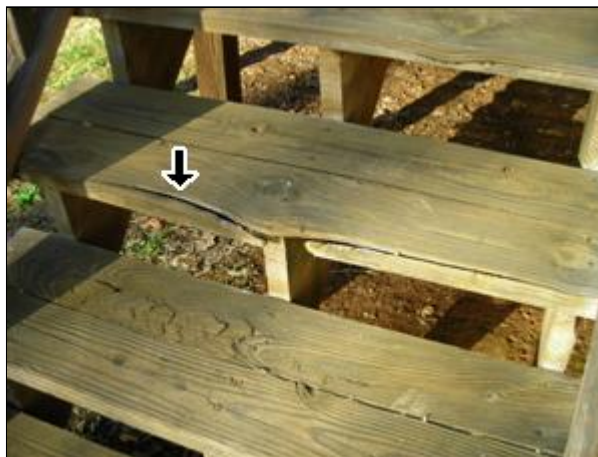
2.4 Picture 2

One of the steps is split on the left side of the deck. See picture 2. If the step were to break while in use, someone could fall.

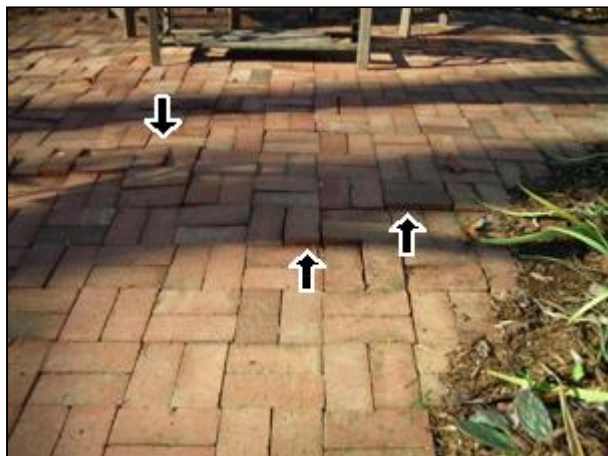
2.5 Picture 1

Some of the bricks in the back walkway have heaved up and could pose a tripping hazard. See picture. I recommend repair by a competent landscaping contractor.

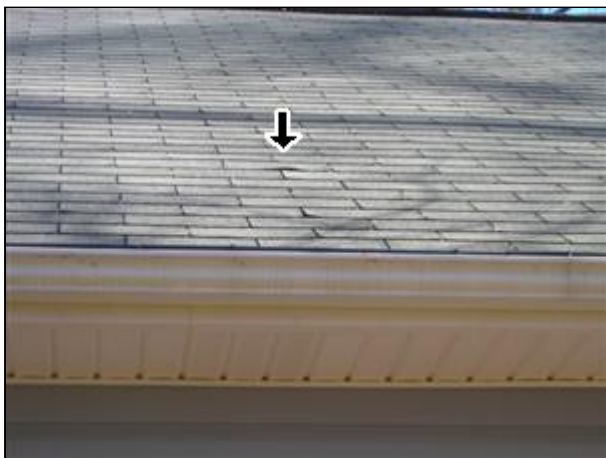
3.0 Picture 1

In a few places, shingles are slightly elevated due to nail pops, where the roofing nails have worked loose and raised the shingle above. See picture 1 for typical example. These places will eventually fail and create leaks as the nail works through the shingle. I recommend the popped nails be removed and the shingles repaired by a qualified roofing contractor.

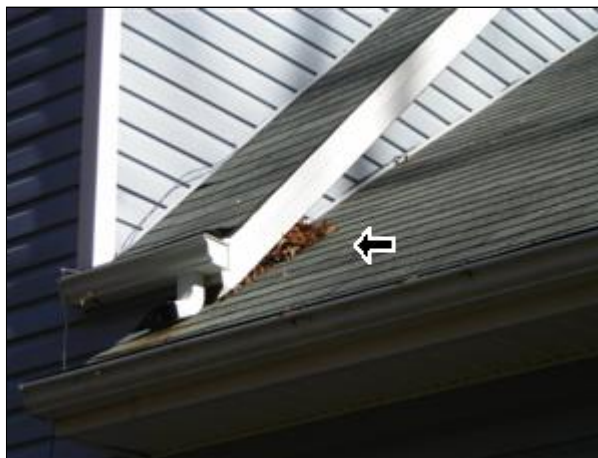
3.0 Picture 2

Leaves are trapped in an angle of the roof on the back side. See picture 2. This could cause a leak if water stands in that area. I recommend removal of the leaves by a competent handy person.

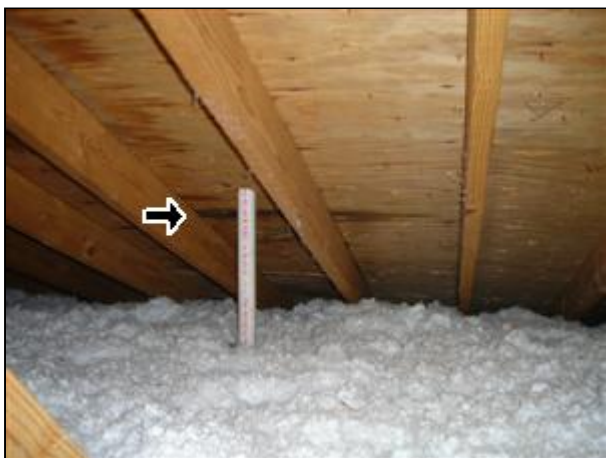
3.2 Picture 1

It is evident from staining on the ceiling of an upstairs bathroom that there is a leak from one of the plumbing vents in the roof. The picture below also shows a stain on the roof decking above this area. I recommend evaluation and repair by a certified roofing contractor.

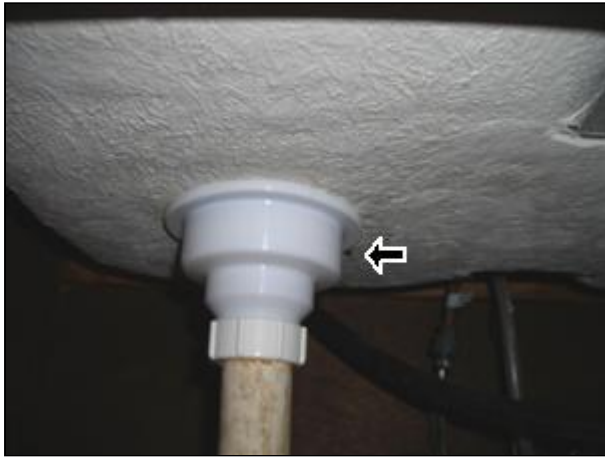
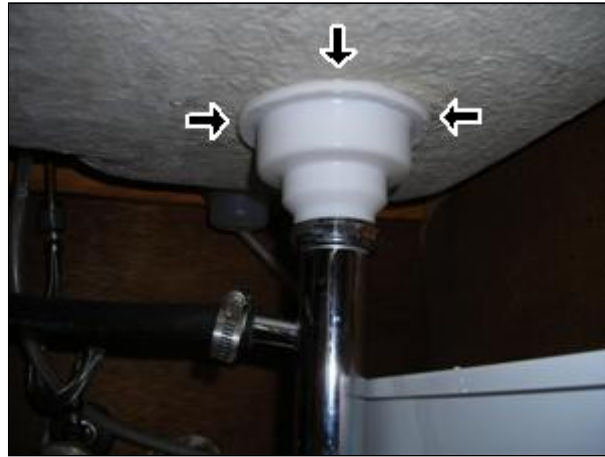
4.0 Picture 1

Both of the drains for the kitchen sink have minor leaks. See pictures 1 and 2.

For the above items, I recommend evaluation and repair by a licensed plumbing contractor.

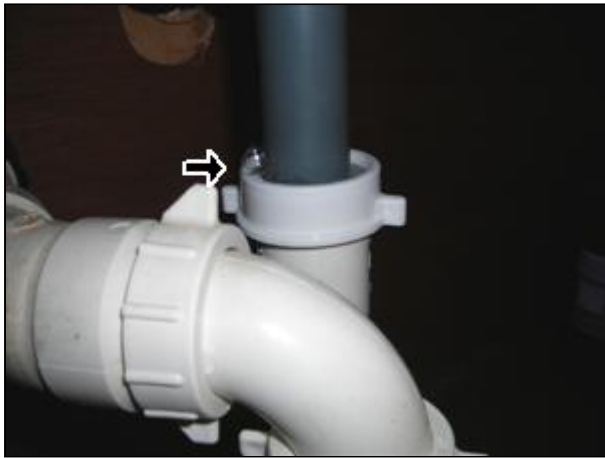
4.0 Picture 3

The drain leaks at the lavatory of the back upstairs bath. See picture 3.

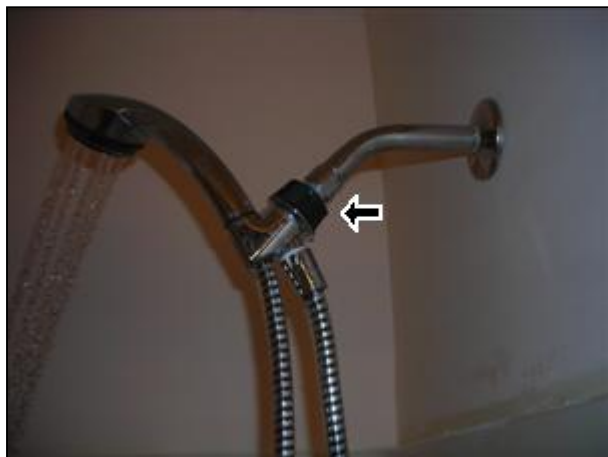
4.1 Picture 1

There is a small leak from the shower head in the upstairs back bath. See picture.

This could be repaired by a licensed plumbing contractor.

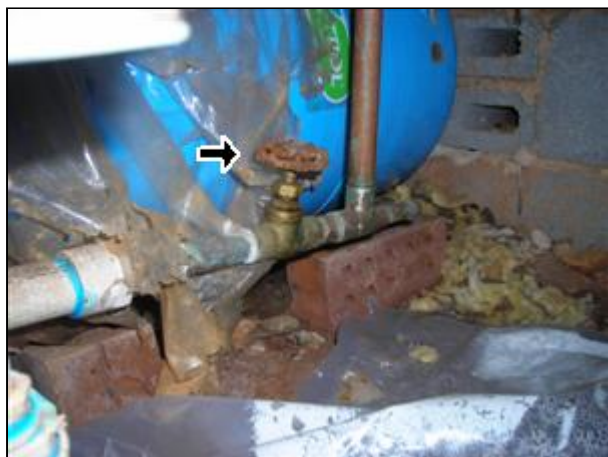
4.3 Picture 1

The main water shut off is located in the crawlspace near the front left corner, at the blue pressure tank. See picture. You may want to consider installing a shut off valve at a more accessible place. Consult a licensed plumbing contractor for more information.

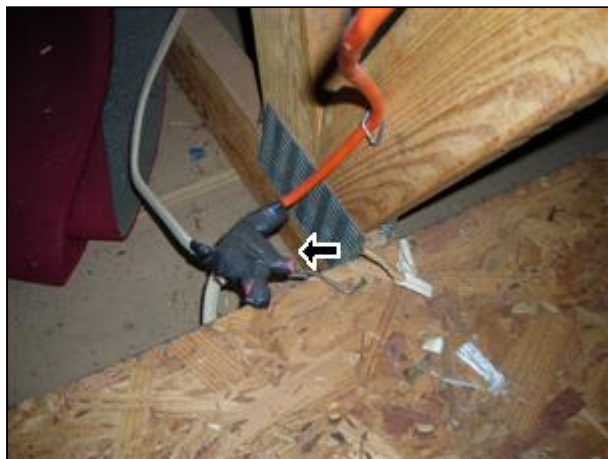
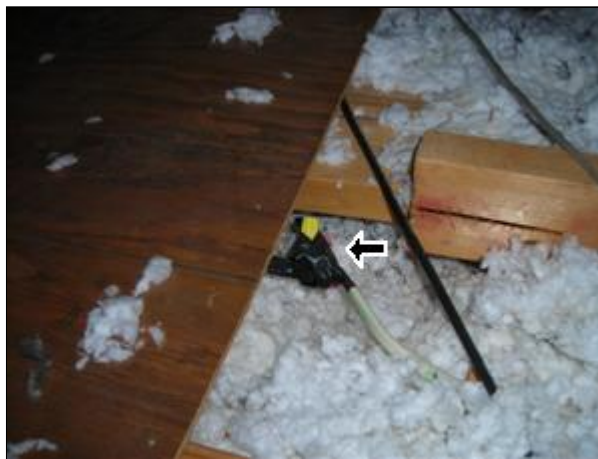
5.2 Picture 1

There are improper splices in both sections of the attic. See pictures. These connections were made to attach the power cables for the attic ventilation fans. Electrical splices should be made in junction boxes so that the wires are protected from damage, and so that workers are protected from electric shock. This could be repaired by a licensed electrical contractor.

The panel has an improper and potentially dangerous generator connection. Breakers connected to auxiliary generators should be set up so that the generator breaker and the main breaker cannot be both turned on at the same time. This panel does not have that feature. Should the main breaker and the generator breaker accidentally be left on at the same time, electricity from the generator could injure workers who may be repairing the electric service far from the house.

I recommend that the electrical system be evaluated and repaired as necessary by a licensed electrical contractor.

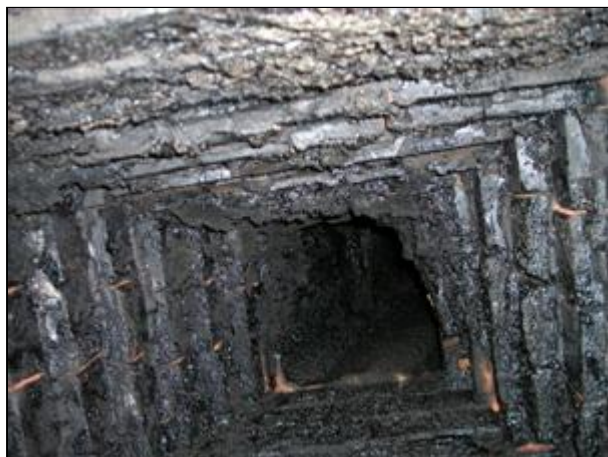
6.3 Picture 1

The fireplace chimney is very dirty. See picture 1. The chimney damper is missing its handle, so the damper will not stay open. I recommend cleaning, evaluation and repair as necessary by a certified chimney cleaner.

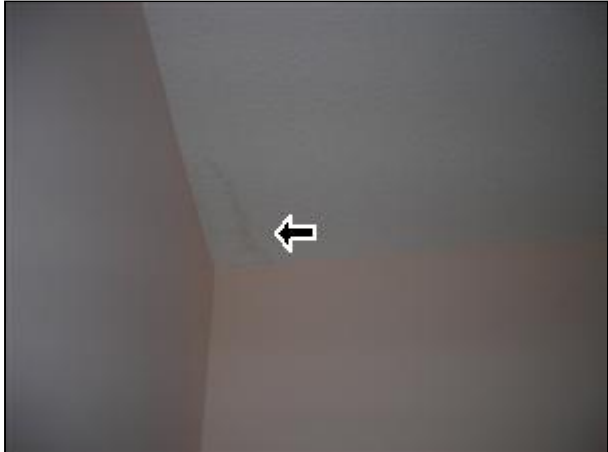
8.0 Picture 1

There is staining of the ceiling in the upstairs back bathroom. See picture. This is from a roof leak, probably from a plumbing vent flashing. See section 3.3 The ceiling could be repaired by a competent painter after the roof leak is repaired.

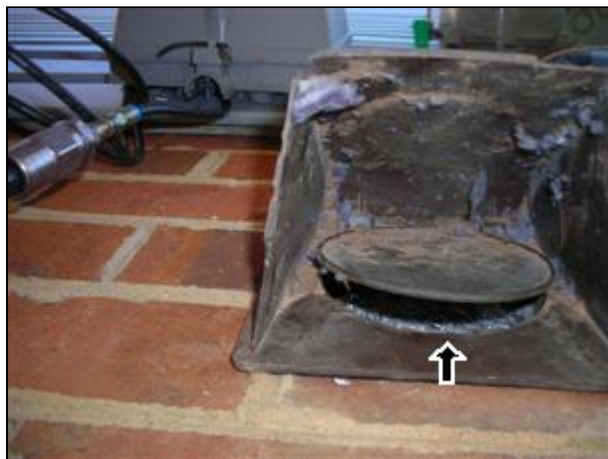
9.2 Picture 1

The dryer vent cap is partially clogged with lint and is stuck in the open position. See picture. This could allow back drafts and pests to enter the ductwork. I recommend that the duct and dampers be cleaned so that they work properly. A competent handy person could make this repair.

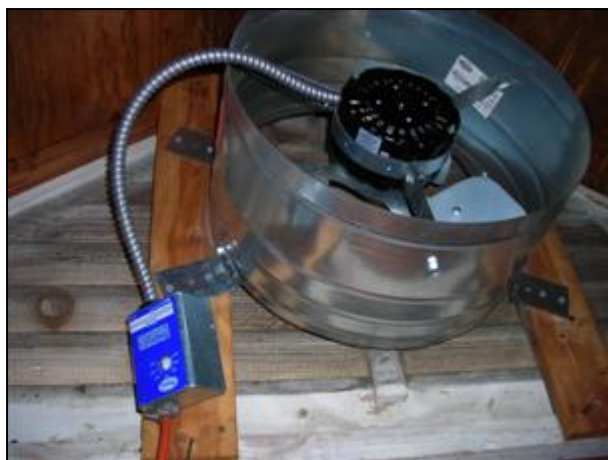
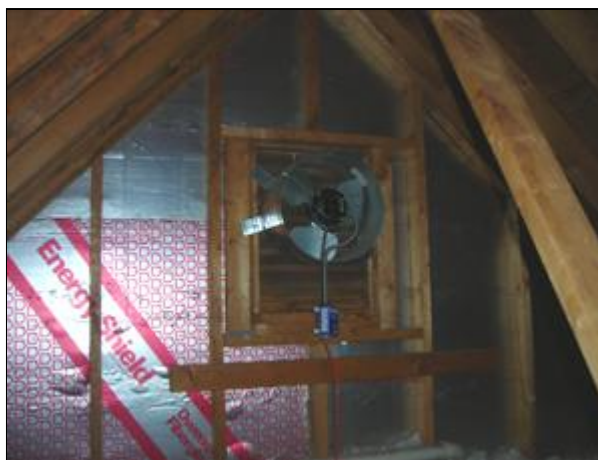
9.3 Picture 1

There are two attic vent fans in this house. See pictures. It was not warm enough in the attic at the time of inspection to adjust the thermostat for the attic vent fans and make the fans operate.
